# WIVENHOE MANAGEMENT GROUP

## **Protecting the Rear Perimeter of a Troubled Hi-Rise Property with a New Advanced Surveillance Deterrent System A Case Study**

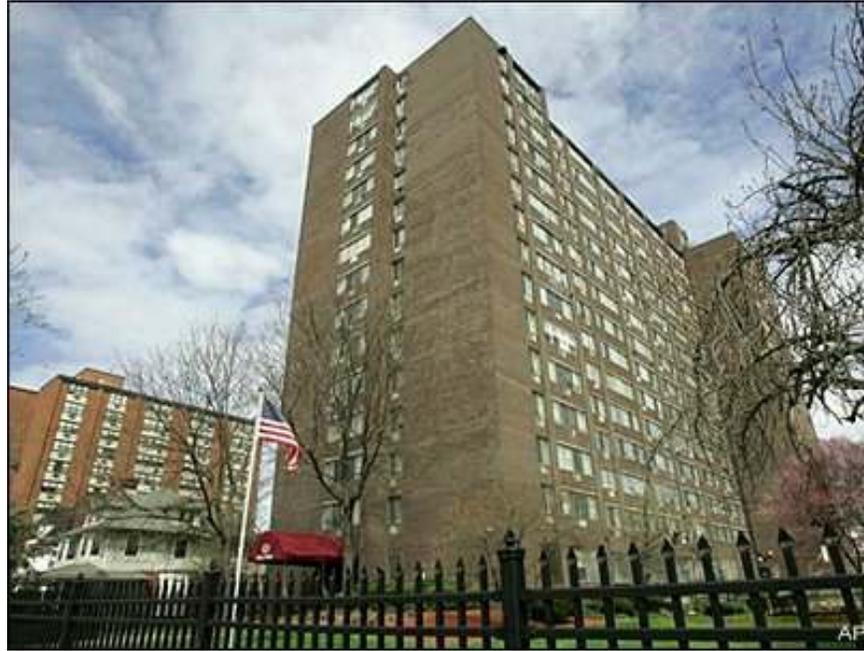
As will be seen from the photo on the next page, the property stands sideways to the main road and the front entrance shown in the picture is not used as the main entrance. The main entrance for tenants is at the end of the front driveway. The rear area includes a dumpster unit, a children playground, basketball area, and is adjacent to a number of private residences, as well as empty derelict housing.

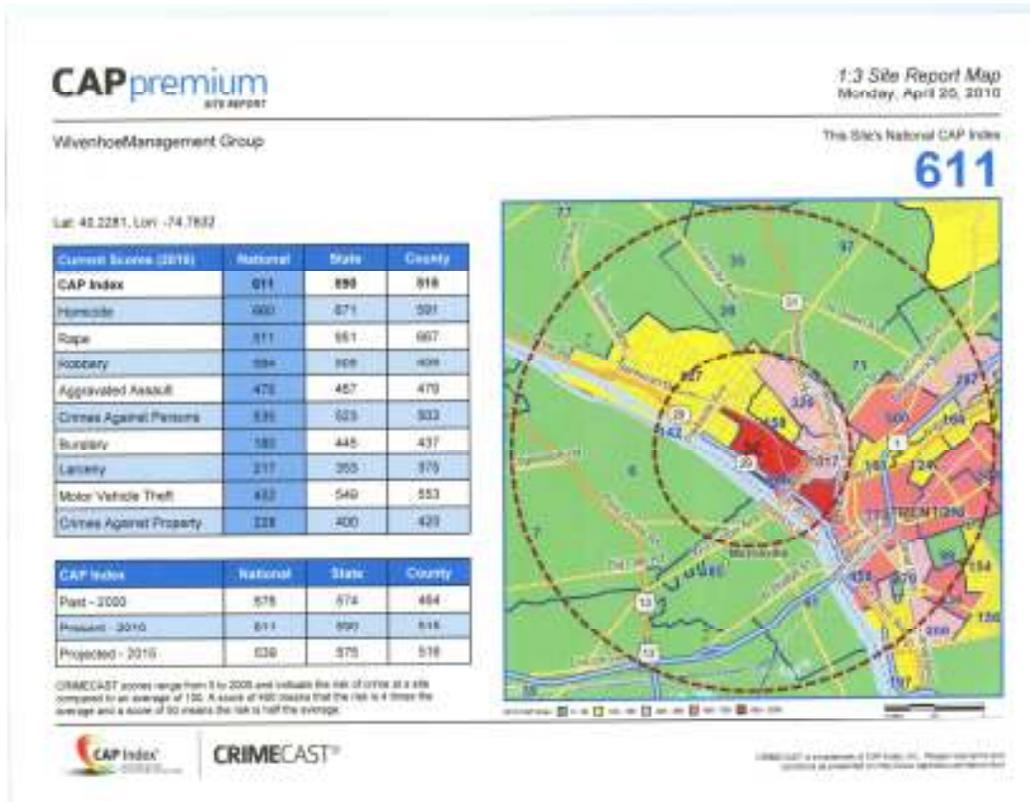
**CAP Index A**

In the first diagram, the areas shown in **RED**, or variations of **RED** indicate high crime sections. The **GREEN** sections indicate low crime rate areas. Unfortunately, Trenton has one of the highest crime rates in New Jersey. In comparison to the National Crime rate, the area where the property resides has an overall crime rate that is 6.11 times the National rate. CAP Index A also shows types of crime in comparison to the National average. In many cases such as Homicide and Robbery, etc., the CAP Index score is significantly higher than the National average.

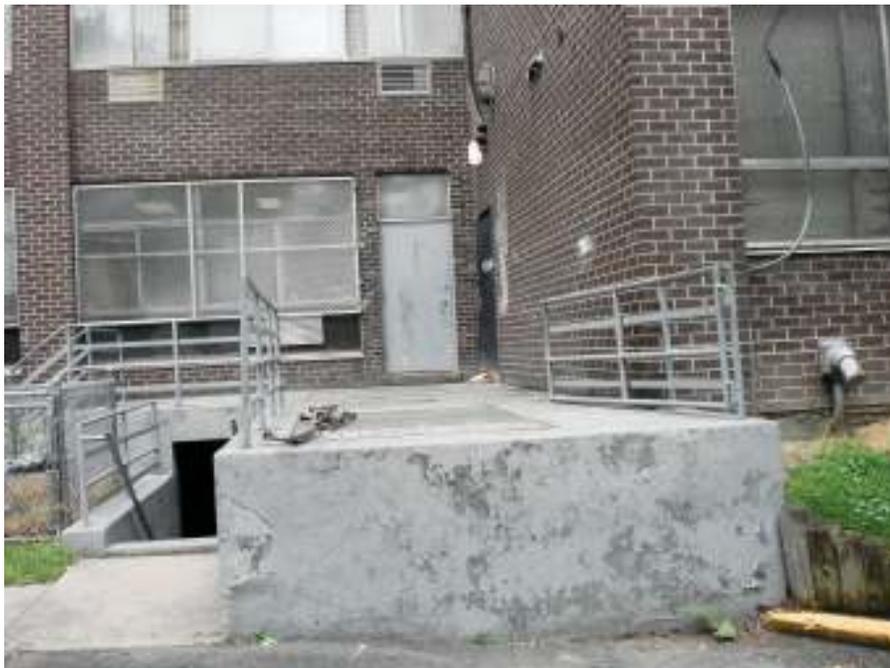
**Rear Side of Building**

Also shown following the CAP Index diagrams are example photos of the rear of the building and adjacent infrastructure providing a grim background picture to the rear perimeter. Prior to implementing the new advanced surveillance deterrent system, the rear area was home to general loitering, tenant children throwing stones and other objects that broke windows in the adjoining private residences, attempted break-ins to the building, the breaking of rear and side windows to the property, and suspected drug dealing.

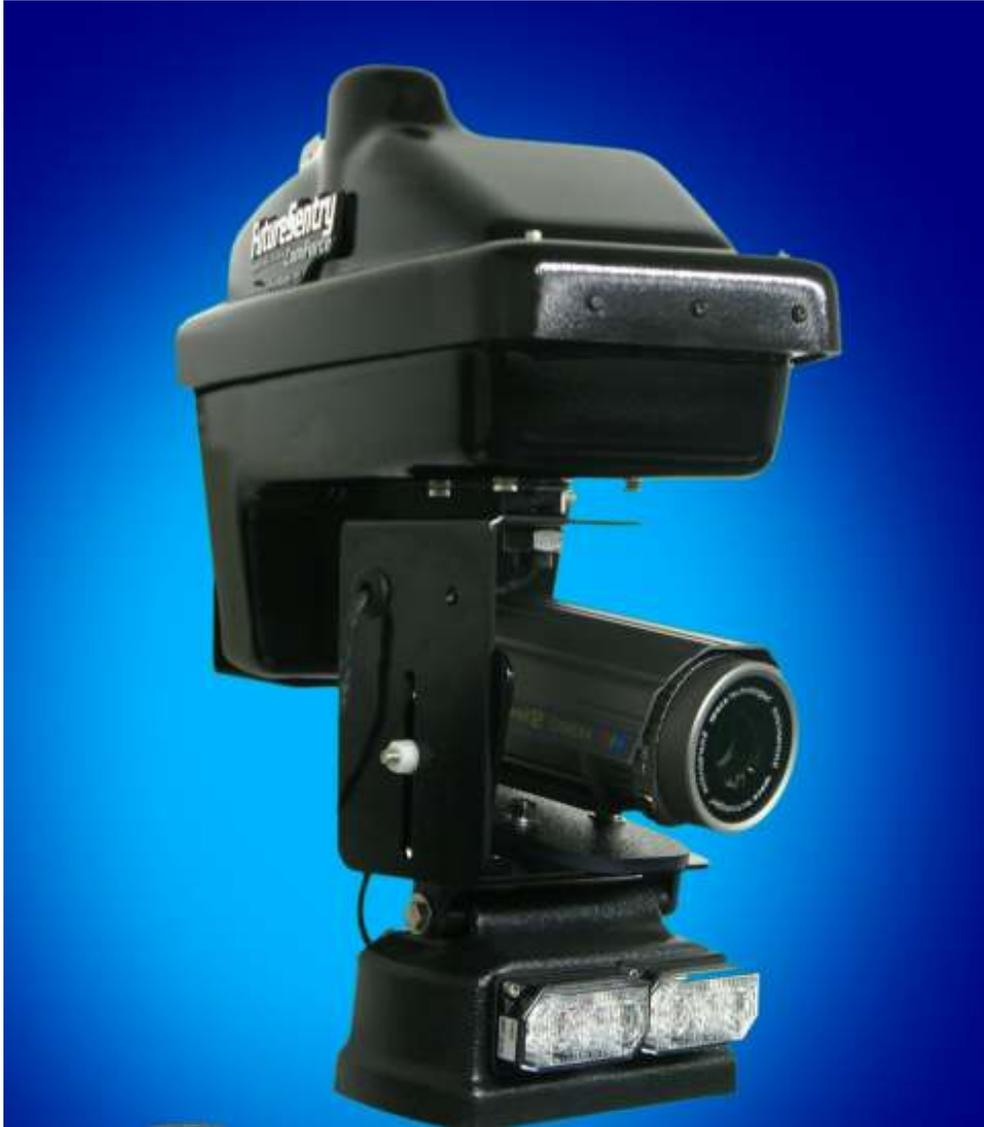
**Manufacturer's Photo of Typical Tracking Platform Equipped with Non-Panasonic Analog Camera**

The first element is an **automated tracking platform** which includes, in this case, a Panasonic IP 1.3 Megapixel camera (WV-502 Series), and a dual set of high intensity LED light units. The platform has the capability to revolve 360 degrees, but in the building rear area situation, 180 degrees was adequate.

The automated tracking platform is shown above and it should be noted that the platform has its own IP Address. The platform unit is weatherproof.

The platform, when triggered by a sensor reacts in the following manner:

1. The high intensity LED light units will immediately flash several times before reverting to a solid illumination that can be seen almost half a mile away.

2. The platform will move to the location of the sensor where the intruder is, moving a little to the left and a little to the right of the intruder position, just as a security guard would do operating a PTZ camera.

5. The light units and camera will continue to focus on the intruder, or follow the intruder as he triggers additional wireless sensors in the rear perimeter area.

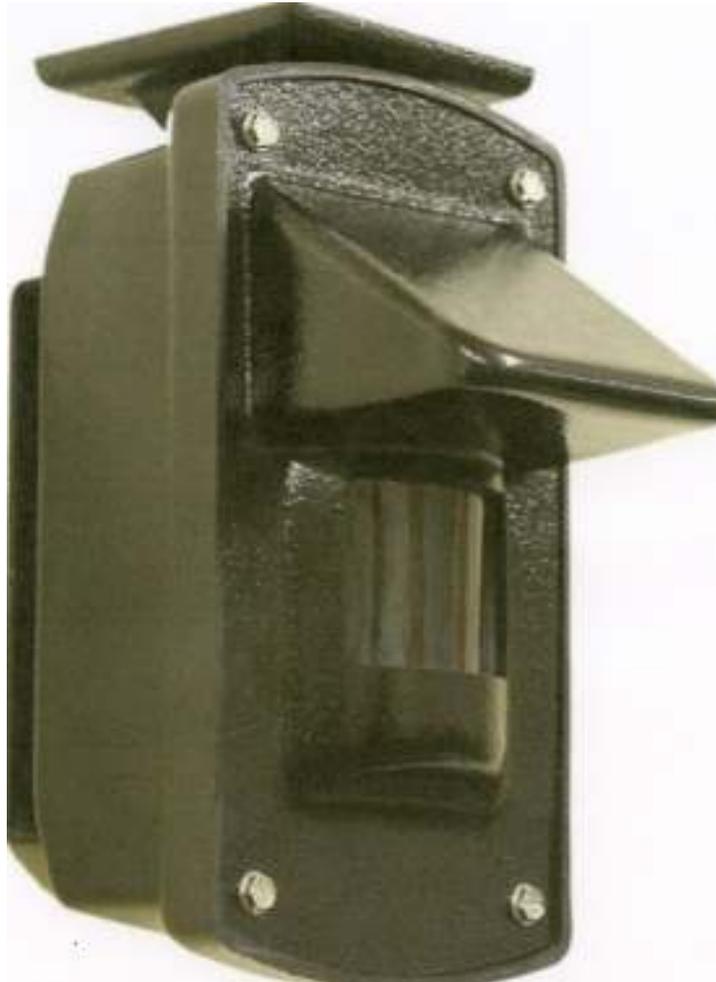
### **Future Sentry Solar Powered Wireless PIR Sensor**

The second element that allows the **automated tracking platform** to track intruders entering the perimeter is a series of **Wireless, Solar Powered PIR Sensors**. The sensor is shown below:

The wireless sensor can be mounted virtually anywhere provided there is reasonable access to sunlight for minimal periods. It has been proven that exposing the wireless sensor unit to six hours of sunlight, will allow the solar charged battery to operate the unit for a minimum period of 80 days.

In the case of the Trenton Hi-Rise Building, only six sensors were required mounted on the wall of the building, and even on a tree.

The operation of the Future Sentry system is transparent to the security guard personnel in that the wireless sensors detect an intruder crossing the PIR beam (there are three types of PIR lens supplied with the sensor), which in turn trigger the automated tracking platform.
